BURLINGTON

BIKE

PATH

IMPROVEMENT

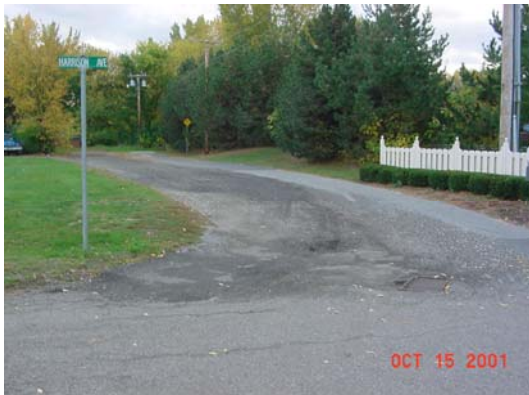
Figure 1: It is difficult to tell where path begins and driveway ends. Further delineate this difference to improve safety.

North of the bridge (Station 11+00 to 15+20), 420' of pavement is in need of more extensive repair/rehabilitation. There is room to expand to 10 feet and establish proper shoulders. When shoulders are established, curbing should be added from station 13+20 to 15+20 (200') to properly delineate between the bike path right-of-way and adjacent driveways.

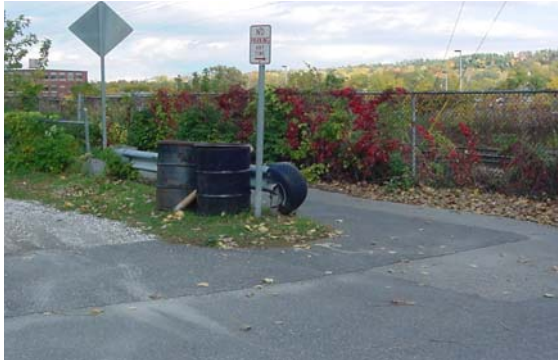
Figure 2: Guardrail where Path meets Harrison Avenue

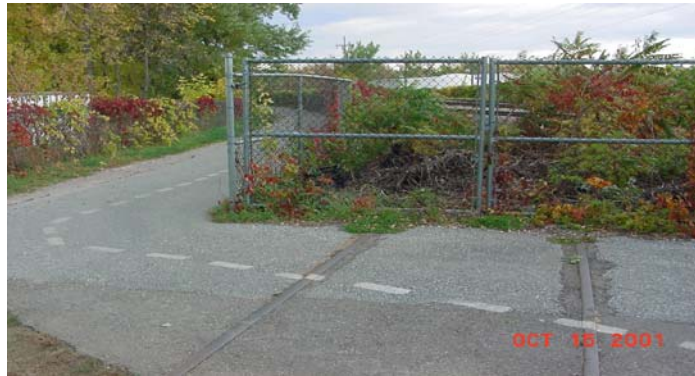
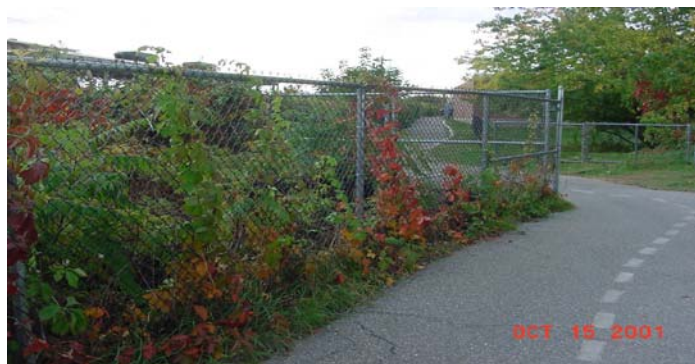
Figures 3 and 4 (above): Blodgett Curve looking north and south

The path takes a dogleg turn just north of the Blodgett building. Sight distance is very poor. The radius of the turn is too tight making it virtually impossible to navigate while staying on the correct side of the path. In addition, an abandoned rail spur crosses the curve at the most critical point.

At the location of the S-curve (Station 35+00), the radius should be increased. This may be accomplished by moving the railroad fence back to flatten the curve. We recommend that the Department of Parks and Recreation request, from the railroad, that the fence be moved closer to the rail and the railroad spur to the Blodgett Building be removed. Blodgett Ovens would have to agree to give up the use of the spur as well. In addition to the increase in width

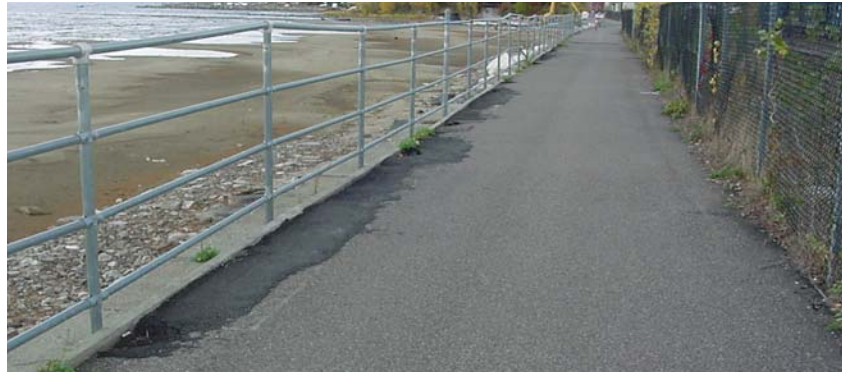
Figure 5: Path erosion near Barge Canal Beach

There appear to be erosion and other drainage related problems that are causing a number of sinkholes along this section. The pavement is uneven through this section. Surface construction is recommended. Sight distance is good here as this section is very straight and flat.

The southern portion of this section (Station 47+50 to 58+00) should be rebuilt with new gravel subbase and asphalt. Drainage issues should be investigated prior to repair to alleviate similar problem in the future. This may require some shallow borings be taken along this section. A fabric liner should be installed before new subbase is put down to minimize the number of washouts. Install new safety railing on the outside of the seawall allowing for an additional 1.5' – 2' of width for path use.

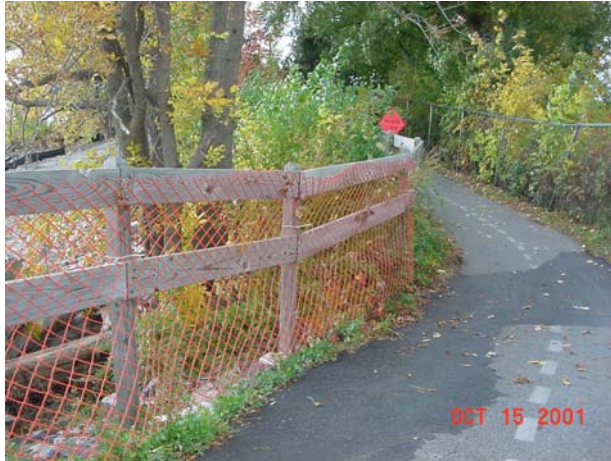
Figure 6: Poor visibility north of Barge Canal Bridge

At Station 58+00 there is a bridge over the mouth of Barge Canal. North of this bridge (Station 58+00 to 61+00) the bike path is eight feet wide with no shoulders. Sight distance is very poor as the path turns west. This problem is a combination of a fairly sharp corner and an overgrowth of vegetation. (see Figure 6). Resurfacing is needed through this area.

Between Station 58+00 and 61+00, aggressive trimming of vegetation is recommended due to very poor sight distance. Provisions should be made here to improve access to the western side of the fence to make maintenance easier. This can be accomplished most easily by installing a gate along this section for access. There is no room for expansion from station 58+00 to 61+00. Pavement overlay through this section 300'.

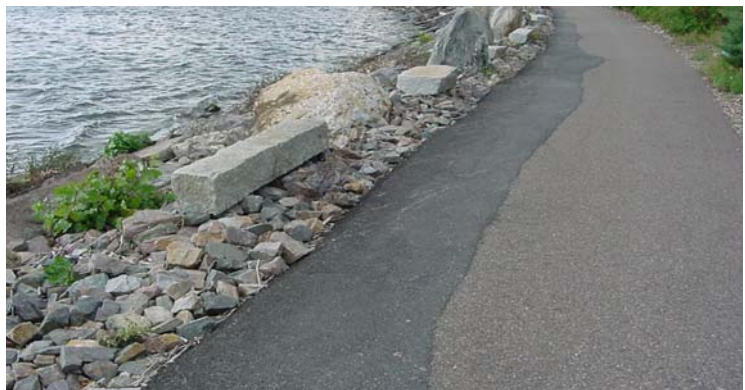
Figure 7: Erosion at riprap wall

extensive work is done along the shoreline to extend the retaining wall, see photo above. The pavement condition is fair. Annual patching is required on the western edge of the path due to water damage, see figure 7 above. Sight distance is good here in this flat, straight section.

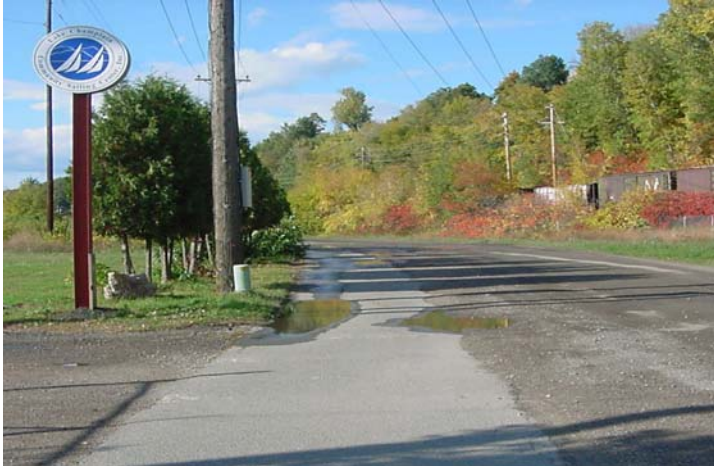
section. An overlay on the entire section is needed. There is ponding near station 121+50 (figure 8), which would be corrected by the resurfacing.

Figure 8: Path intersects with Sailing Center Drive - Ponding Evident

The pavement condition is very poor. Grinding and paving is recommended from Station 112+00 to 145+00.

Widen to the east to 10 feet. This eliminates the need to move hydrants and eliminate utility/sign poles. The road is narrowed under this scenario, however, the road is more than wide enough to accommodate this work. Regrade, prior to paving, to improve drainage and pavement condition.

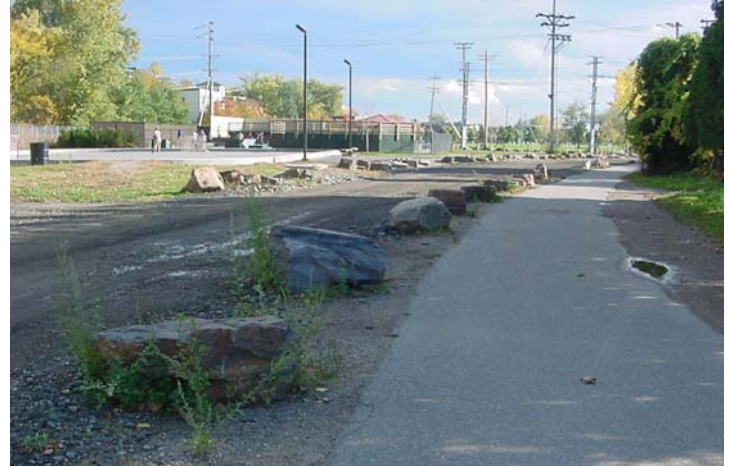
Figure 9: Boulders to shift east for path expansion

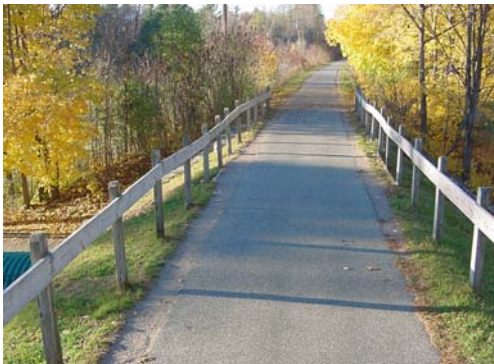
Figure 10: Path over North Beach Culvert (left)

Install warning and promotional signing to alert path users of North Beach and its amenities. (See Figure 11 for photo.) Extend the fencing in each direction over the North Beach access culverts to protect the entire slope. (See Figure 10 for photo.)

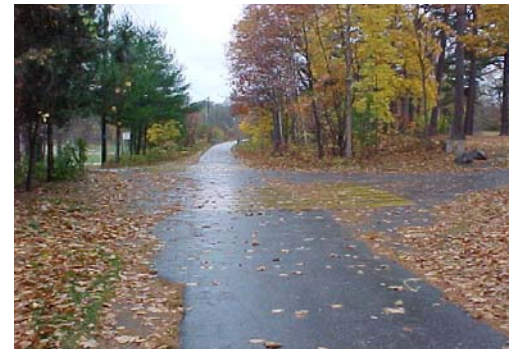
Figure 11: Intersection with North Beach Access Road (right)

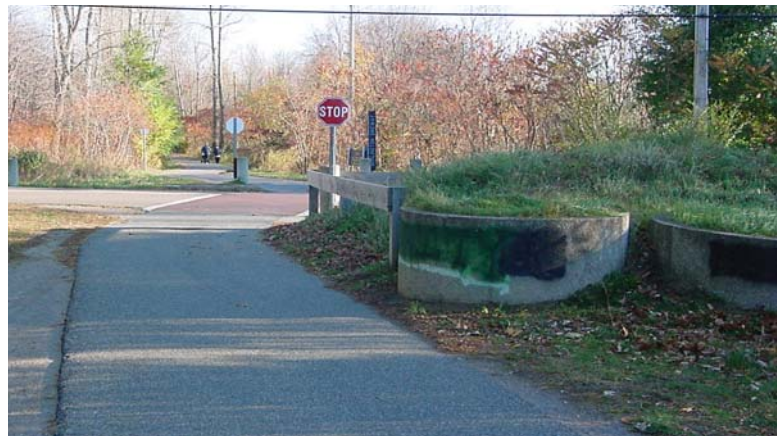
Pavement condition is generally good with minor cracking. Sight distance is adequate at the Shore Road intersection. More signage and striping may be needed at the approaches to the intersection. Sight distance is poor at the Staniford Road intersection due to a raised water main. Raised crosswalks at both intersections alert motorists to the crossing. Signing and striping on the path could be added to warn users of the upcoming intersection.

Figure 12: Poor Sight Distance at Staniford Road Intersection

Eliminate the vegetation on top of the mound at the northwest corner (see figure 12) of Staniford Road. New pipe or insulating material

which better protects the existing water main from harsh weather conditions may be available for use at this location. Install signs to alert users of poor sight distance.

The Staniford Road water line will be replaced with new material which will allow the cutting down of the high vegetation that is currently causing sight distance problems in this area.

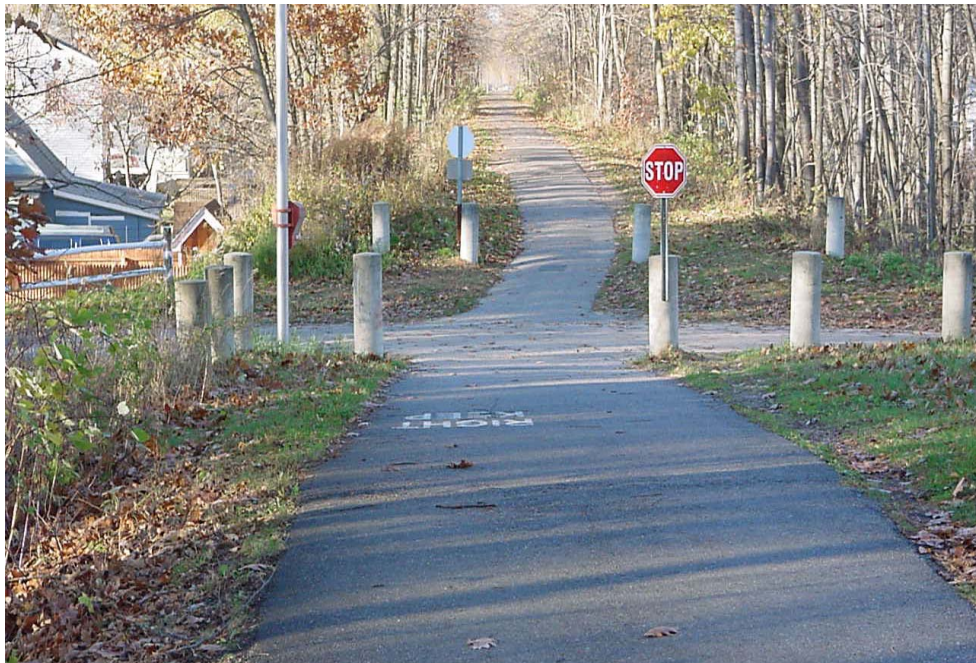
The intersection of the path with North Avenue Extension has a steep approach from both north and south. Users must come to a quick stop to avoid rolling down into the road. Figure 13 below does not do justice to the sudden elevation drop prior to the intersection.

Figure 13: Looking North at the North Ave. Extension Intersection
